Streamline Series VNA & PC setup procedure and its Troubleshooting tips

Keysight Technologies
30-Mar-2026

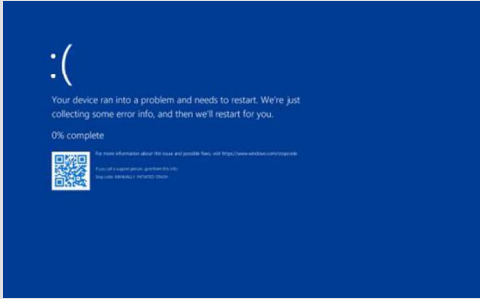
| Symptom | Possible root cause | Solution |
|--|---|--|
| <p>#1-3 BSOD (Blue Screen Of Death) is shown</p> | | <p>Go to Windows 11 BSODs Automatic Repair and advanced troubleshooting options - Microsoft Community</p> <p>Refer to Bug Check Code Reference - Windows drivers Microsoft Learn for more details.</p> |

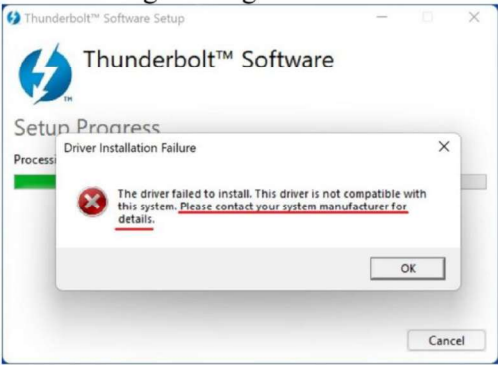
| Symptom | Possible root cause | Solution |
|--|--|---|
| <p>#2-3-1 Driver Installation Failure is shown on Intel Gen12 CPU with Windows 11</p> | <p>For Intel Gen12 CPU, Windows 11 OS already contains the necessary driver for Thunderbolt device to work properly.</p> | <p>No action is needed. Refer to Troubleshooting Tips #3-7-3.</p> |

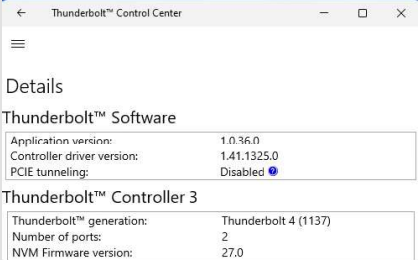
| Symptom | Possible root cause | Solution | | | | | | | | | | | | |
|--|---|---|---|---|---|---|---|---|---|---|---|---|---|--|
| <p>#2-3-2 PCIe tunneling is Disabled</p> <p>Thunderbolt™ Control Center</p> <p>Details</p> <p>Thunderbolt™ Software</p> <table border="1"><tr><td>Application version:</td><td>1.0.36.0</td></tr><tr><td>Controller driver version:</td><td>1.41.1325.0</td></tr><tr><td>PCIe tunneling:</td><td>Disabled</td></tr></table> <p>Thunderbolt™ Controller 3</p> <table border="1"><tr><td>Thunderbolt™ generation:</td><td>Thunderbolt 4 (1137)</td></tr><tr><td>Number of ports:</td><td>2</td></tr><tr><td>NVM Firmware version:</td><td>27.0</td></tr></table> <p>When PCIe tunneling is disabled, some Thunderbolt™ devices, including external GPUs and storage drives, may not work properly. PCIe tunneling settings may be changed in BIOS.</p> | Application version: | 1.0.36.0 | Controller driver version: | 1.41.1325.0 | PCIe tunneling: | Disabled | Thunderbolt™ generation: | Thunderbolt 4 (1137) | Number of ports: | 2 | NVM Firmware version: | 27.0 | <p>PCIe tunneling setting in BIOS might be incorrect.</p> | <p>Step-1: If you are setting up with desktop-PC, confirm the PCIe Thunderbolt card is installed to the appropriate slot which supports PCIe tunneling.</p> <p>Step-2: If the symptom still occurs, go to PC BIOS setting menu and enable PCIe tunneling. [samples of BIOS setting] <u>Dell Desktop PC BIOS (UEFI)</u> BIOS Setup > Integrated devices > Disable USB4 PCIe Tunneling > Off</p> <p><u>HP Laptop PC BIOS (UEFI)</u> HP Computer Setup > Advanced > Thunderbolt Options > Enable Thunderbolt Mode</p> |

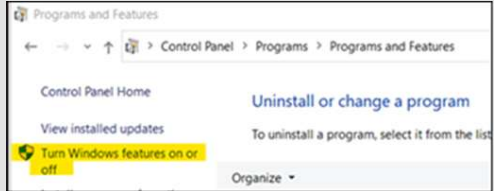
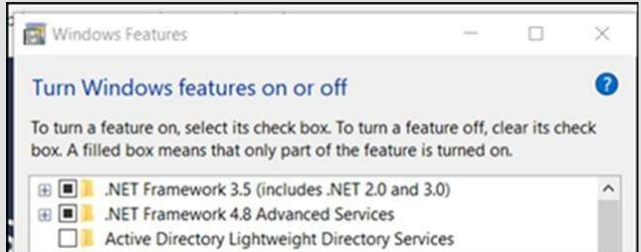
| Symptom | Possible root cause | Solution |
|---|---|---|
| #2-4-2 .NET Framework 3.5 is not enabled | | <ol style="list-style-type: none">① Enter Control Panel at Windows Search② Navigate to Programs > Programs and Features > Turn Windows Features on or off③ Enable the .NET Framework 3.5④ Re-boot the PC <p>For more details, go to https://docs.microsoft.com/en-us/dotnet/framework/install/dotnet-35-windows</p> |

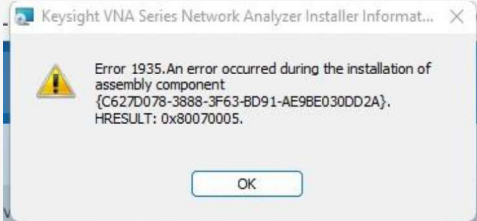
| Symptom | Possible root cause | Solution |
|--|---|--|
| #2-5-2 Error 1935 is shown while installing VNA firmware. | During the VNA firmware installation, required permissions are missing, or .Net Framework setting is not correct. | <ol style="list-style-type: none">① Re-boot the PC and install the latest VNA firmware again. Make sure the VNA firmware is installed with “Run as administrator” capability.② If the symptom still occurs, disable any anti-virus, anti-spyware or firewalls while installing VNA firmware.③ If the symptom still occurs, go to Troubleshooting tips #2-4-2. <p>For more details, go to Download Microsoft .NET Framework Repair Tool from Official Microsoft Download Center</p> <ol style="list-style-type: none">④ If the symptom still occurs, go to Troubleshooting tips #1-2. |

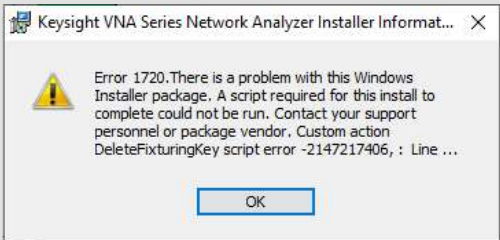
| Symptom | Possible root cause | Solution |
|---|---|---|
| <p>#2-5-3 Error 1720 is shown while installing VNA firmware</p> | <p>There is a problem with Windows Installer Package.</p> | <p>Go to Error 1720: There is a problem with this Windows Installer package. A - Microsoft Community</p> <p>If the symptom still occurs, go to Troubleshooting tips #1-2.</p> |

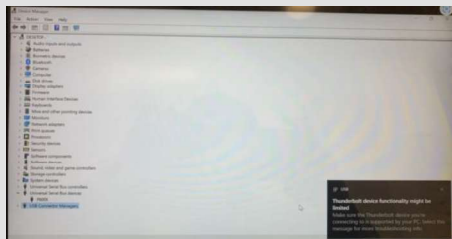
#3-1
Thunderbolt device functionality might be limited is shown in Device Manager

Thunderbolt device functionality might be limited
Make sure the Thunderbolt device you're connecting to is supported by your PC. Select this message for more troubleshooting info.

Replace USB-C cable with the Thunderbolt 3 cable included in the Streamline Series VNA

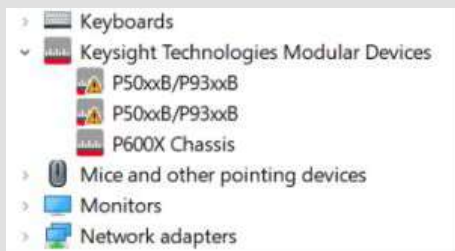
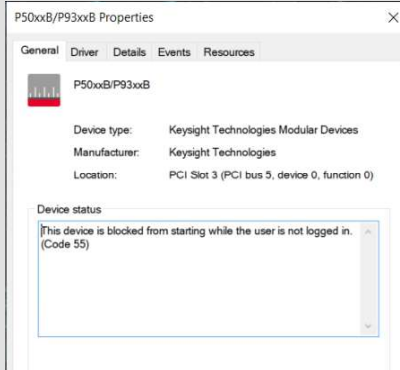
#3-6-4
For B model, Code 55 error is shown in Device Manager

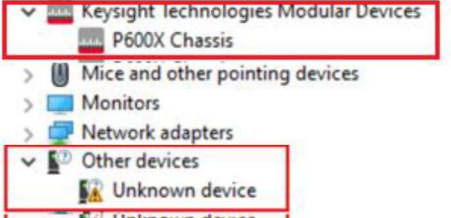
| Symptom | Possible root cause | Solution |
|---|--|---|
| <p>#3-6-6 No VNA device(s) is/are shown under Keysight Technologies Modular Devices, but VNA device(s) is/are shown under Other devices</p> | <p>Windows does not recognize VNA device(s) correctly, since P50xx drivers are not installed correctly.</p> <p>[Known Issue on A15.75.19 for Streamline Series VNA (P50xxA/B, P93xxA/B)]: The unit will not be detected if you install the firmware from scratch. The driver for Chassis is not installed at this version.</p> | Go to Troubleshooting Tips #2-5-1 |

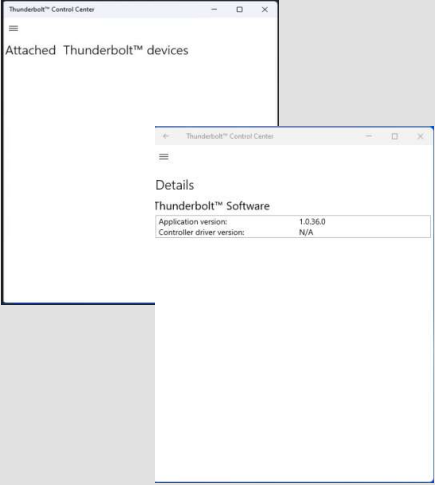
| Symptom | Possible root cause | Solution |
|--|---|--|
| <p>#3-7-3 P600X is not shown in Thunderbolt Control Center application on PC of Windows 11 OS .</p> <p>The screenshot shows two windows of the Thunderbolt Control Center application. The top window is titled 'Thunderbolt™ Control Center' and has a header 'Attached Thunderbolt™ devices'. The bottom window is also titled 'Thunderbolt™ Control Center' and has a header 'Details'. Under 'Details', it says 'Thunderbolt™ Software' and lists 'Application version: 1.0.36.0' and 'Controller driver version: N/A'.</p> | <p>P50xxB/P93xxB is connected to PC of Gen12 or later CPU with Windows 11 OS through USB4 connection manager.</p> | <p>This is not an issue on PC of Gen12 or later CPU with Windows 11 OS, when Keysight Connection Expert shows the required devices. No action is required.</p> <p>Introduction to the USB4 connection manager in Windows Microsoft Learn</p> |

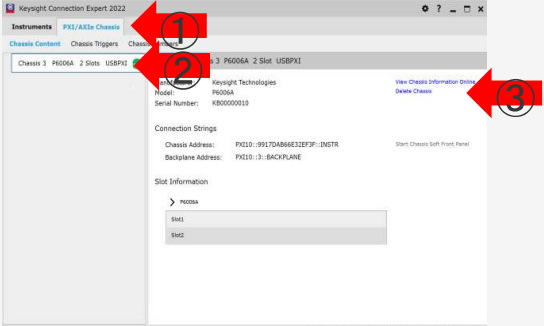
| Symptom | Possible root cause | Solution |
|--|--|---|
| <p>#3-8-4 P6005A or P6006A is shown under PXI (PXI10)</p> | <p>Device Manager cannot recognize PXI Chassis</p> | <p>Launch Keysight Connection Expert</p> <ol style="list-style-type: none">① Click PXI/AXIe Chassis② Select P6005A or P6006A③ Click Delete Chassis <ol style="list-style-type: none">④ Close Keysight Connection Expert and re-boot the PC |

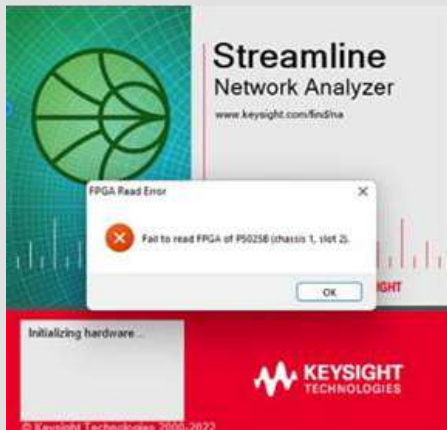
#3-10-1
Fail to read FPGA of Pxxxxx
(chassis x, slot x) is shown while
Initializing hardware.

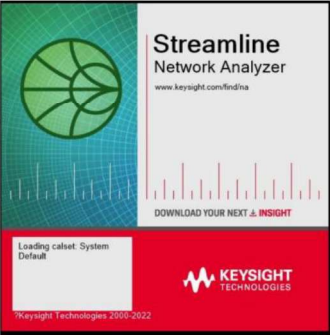
| Symptom | Possible root cause | Solution |
|--|--|---|
| <p>#3-10-3 VNA firmware halts at “Loading Calset”</p> <p>The screenshot shows the Streamline Network Analyzer software interface. At the top, it says 'Streamline Network Analyzer' with the website 'www.keysight.com/find/na'. Below that is a red banner with the text 'DOWNLOAD YOUR NEXT INSIGHT'. The main area displays a graph with a red line. At the bottom, a red box contains the text 'Loading calset: System Default' and the Keysight Technologies logo. The footer reads '© Keysight Technologies 2000-2022'.</p> | <p>Combination issue between VNA firmware and HPP5.3</p> | <p>Install VNA firmware A.15.75.22 or newer</p> |

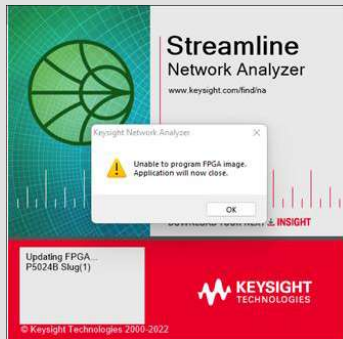
#3-10-4
“Unable to program FPGA image.
Application will now close”
message is shown, while updating
VNA FPGA.

The root cause of this issue is due to declined Thunderbolt signal quality on PCIe Thunderbolt card for Desktop PC or Thunderbolt cable.

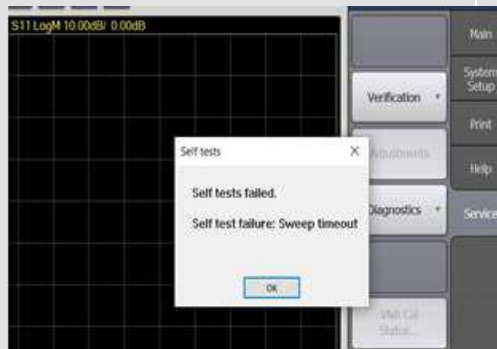
#3-10-5
“Self test failure: Sweep timeout”
error message is shown

Interconnect cables for LO or control cable is not connected properly or broken.

- ① Check if the control cable (Black) is connected properly. If the connection is missing or loosened, connect it and tighten it with the nuts as shown in the image below.
- ② If the symptom still occurs, replace the control cable.

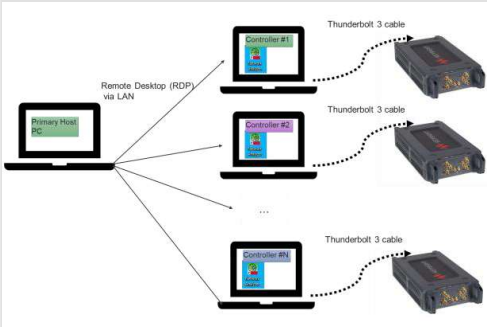
| Symptom | Possible root cause | Solution |
|--|---|---|
| <p>#3-10-7 [Streamline Series VNA B model only] When user tries to access Streamline B model remotely via Remote Desktop (remote logon after controller PC reboot), Streamline B model cannot be recognized until user manually logon the controller PC with physical keyboard.</p> | <p>Windows Kernel DMA Protection blocks an external access to Thunderbolt device.</p> <p><i>When Kernel DMA Protection is enabled: Peripherals with DMA Remapping-compatible device drivers are automatically enumerated and started Peripherals with DMA Remapping-incompatible drivers are blocked from starting if the peripheral was plugged in before an authorized user logs in, or while the screen is locked. Once the system is unlocked, the peripheral driver is started by the OS, and the peripheral continues to function normally until the system is rebooted, or the peripheral is unplugged. The peripheral will continue to function normally if the user locks the screen or signs out of the system. Kernel DMA Protection Microsoft Learn</i></p> | <p>Solution 1: Disable Kernel DMA Protection. For more information on how this works and how to prevent it, refer to the following document from Microsoft and configure it appropriately https://docs.microsoft.com/en-us/windows/security/information-protection/kernel-dma-protection-for-thunderbolt</p> <p>Solution 2: Enable auto-logon to Windows. If user intends to enable the Kernel DMA Protection function, configure the controller PC to enable auto-logon upon reboot. For more information on how this works, refer to the following document from Microsoft and configure it appropriately. https://learn.microsoft.com/en-us/sysinternals/downloads/autologon</p> |

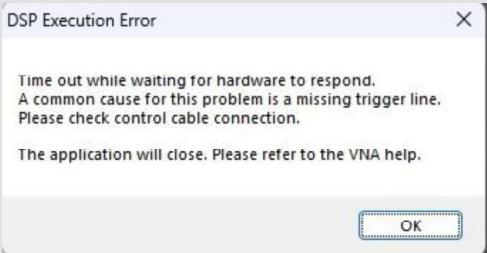
| Symptom | Possible root cause | Solution |
|--|---|---|
| <p>#3-10-10 DSP Execution Error is shown</p> | <p>When DSP cannot receive the whole measurement data within the specified time, this error message is shown.</p> <p>There are some root causes found.</p> <p>#1. Command list size is bigger than FPGA processing capability</p> <p>#2. Contact failure due to</p> <ul style="list-style-type: none">• PCIe connector lubricant• control cable connector contamination• control cable physical stress.• solder residual on backplane board• flux residual on backplane board | <p>Step1: Check if control cable is connected properly. Go to Troubleshooting tips #3-10-5.</p> <p>Step2: If the symptom still occurs, try Workaround for #1. Workaround for #1 If user measures multiple sweeps per channel, VNA firmware sends one command list per channel. Keysight workaround proposal is to send one command per sweep. Ask Keysight for more details.</p> <p>Step3: If the symptom occurs continuously, return it to Keysight for repair.</p> |

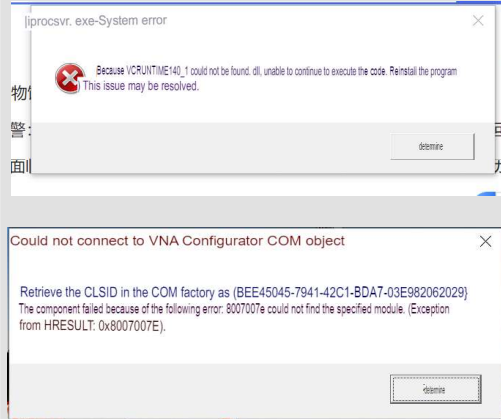
#3-10-11
DLL & COM error is shown.

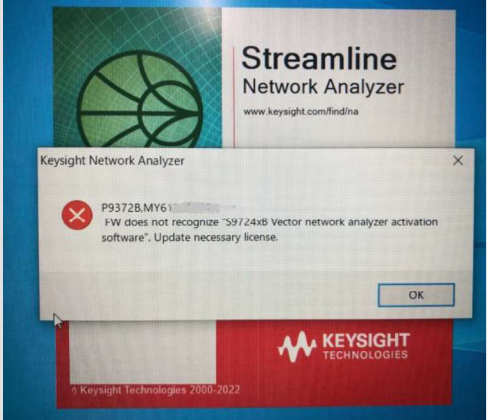
| Symptom | Possible root cause | Solution |
|---|---|---|
| <p>#3-10-12 FW does not recognize "S97824xB Vector network analyzer activation software" Update necessary license pop-up is shown.</p> | <p>FW bug to check the required license</p> | <p>Install VNA firmware A.15.60.05 or newer</p> |

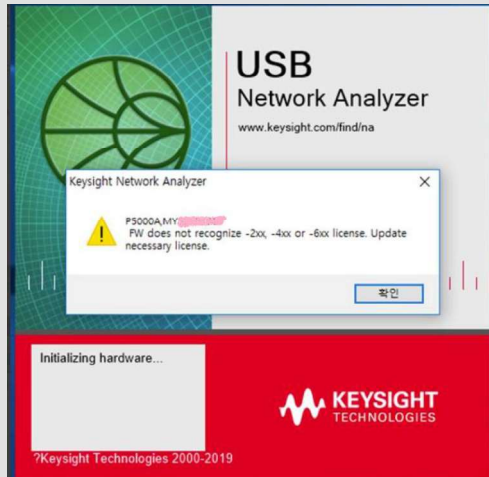
#3-10-13
FW does not recognize -2xx,-4xx
or -6xx license. Update necessary
license pop-up is shown.

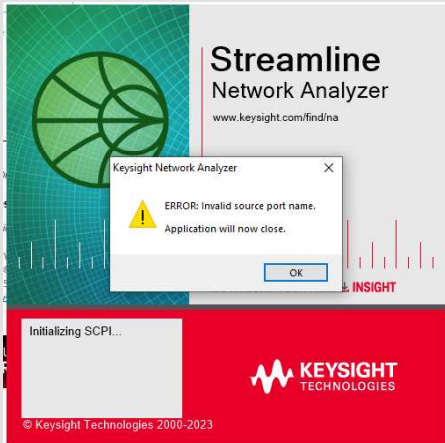
#3-10-14
Invalid source port name error is shown.

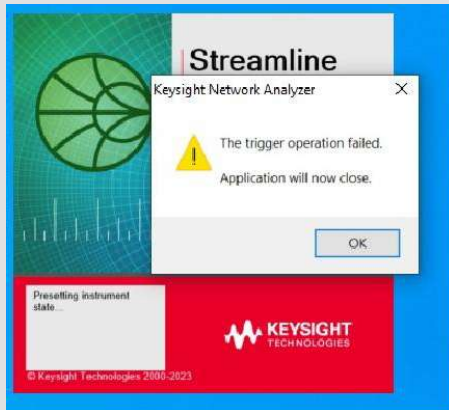
#3-10-15
The trigger operation failed.
Application will now close error is shown.

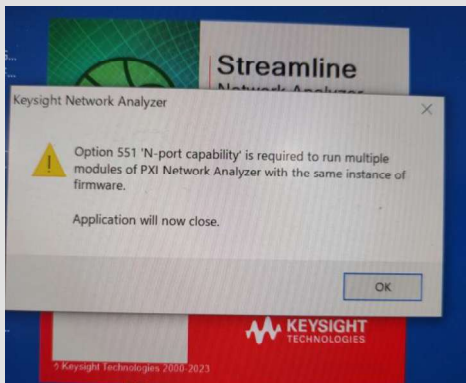
#3-10-16
Option 551 'N-port capability' is required error is shown.

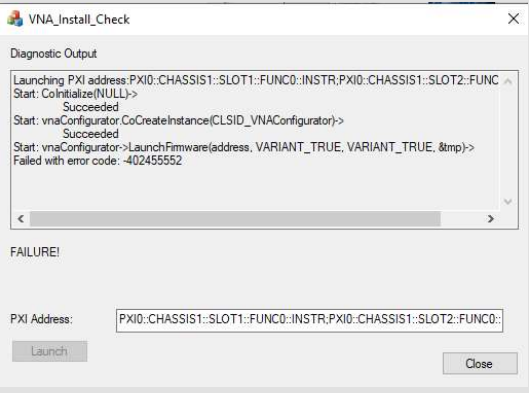
| Symptom | Possible root cause | Solution |
|---|---|--|
| #3-10-18 Other VNA firmware installation issue | | <p>Further investigation is required to solve the VNA firmware installation issue.</p> <ol style="list-style-type: none">① Download the diagnostic tool (VNA_Install_Check.exe) from https://files.keysight.com/dl/ljMqqBP1rm② Launch the diagnostic tool③ If you see Failure!, copy the Diagnostic Output and send it to Keysight. <p>The screenshot shows a window titled 'VNA_Install_Check' with a 'Diagnostic Output' section. The output text is as follows:</p> <pre>Launching PXI address:PXI0:CHASSIS1::SLOT1::FUNC0::INSTR;PXI0:CHASSIS1::SLOT2::FUNC0: Start: CoInitialize(NULL)-> Succeeded Start: vnaConfigurator.CoCreateInstance(CLSID_VNAConfigurator)-> Succeeded Start: vnaConfigurator->LaunchFirmware(address, VARIANT_TRUE, VARIANT_TRUE, &tmp)-> Failed with error code: -40245552</pre> <p>Below the output, the word 'FAILURE!' is displayed. At the bottom, there is a 'PXI Address:' label with a text box containing 'PXI0:CHASSIS1::SLOT1::FUNC0::INSTR;PXI0:CHASSIS1::SLOT2::FUNC0:'. There are 'Launch' and 'Close' buttons at the bottom of the window.</p> |
