Streamline Series VNA & PC setup procedure and its Troubleshooting tips

Keysight Technologies
30-Mar-2026

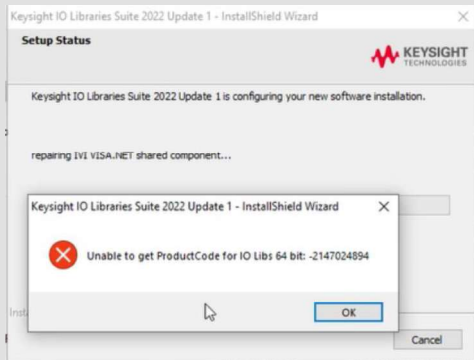
#2-4-3
Unable to get ProductCode for IO
Libs 64 bit error is shown

Some files or registries were not removed
correctly.

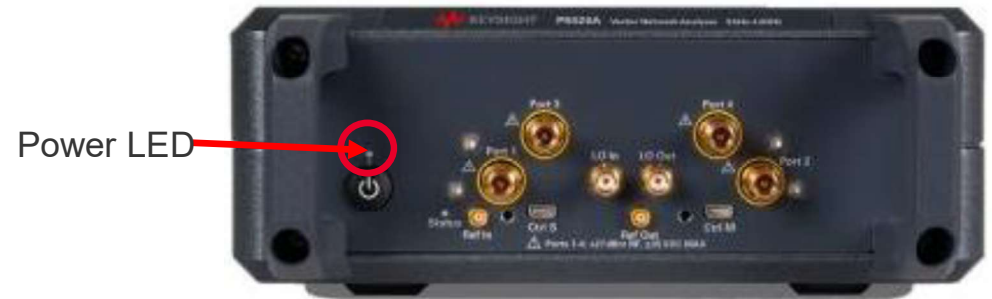
3-3-1. Power LED does not turn green

| Symptom | Possible root cause | Solution |
|--|---|---|
| #3-3-1-1 Not glowing amber when power adapter is connected to VNA | Power adapter or power line in the VNA is broken. | Return it to Keysight for repair |
| #3-3-1-2 Blinking red | Power adapter does not supply enough power | <ol style="list-style-type: none"> ① Check if proper power adapter is used (See 3-2). If KPN 0950-6128 is used to Streamline Series VNA 4-/6- port model, replace it with KPN 0950-6166. ② Retry powering on the VNA. If the symptom still occurs, return it to Keysight for repair. |
| #3-3-1-3 Glowing red | PC does not recognize the VNA | <ol style="list-style-type: none"> ① Check the power on sequence. <ol style="list-style-type: none"> 1. Connect the cable between PC and the VNA (See 3-1) 2. Power on the VNA (See 3-2, 3-3) 3. Power on the PC (3-4) ② If the symptom still occurs, return it to Keysight for repair. |

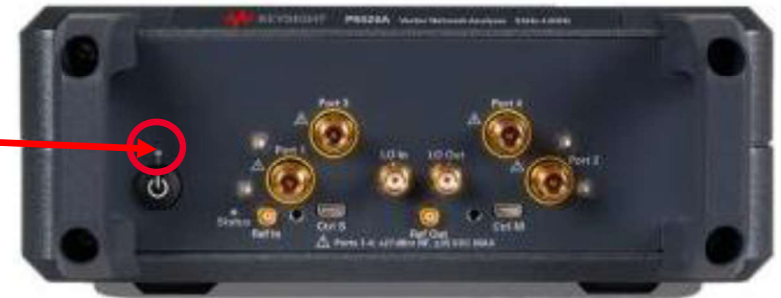
Power LED

| Symptom | Possible root cause | Solution |
|--|--|--|
| #3-3-1-4 Once glowing green for a few seconds, then shutdown automatically Impacted model: 2-port VNA only | VNA firmware version A.15.60.05 or newer has a function to shutdown automatically when in-rush voltage drop event is detected. [This is intended behavior] | <ol style="list-style-type: none"> Check if VNA firmware version A.15.55.14 or newer. If VNA firmware version is A.15.60.05 or newer, the firmware has a function to shutdown automatically when in-rush voltage drop event is detected. Retry powering on the VNA. If the symptom still occurs, return it to Keysight for repair. |
| #3-3-1-5 Glowing blue | Chassis FPGA update failed. | Return it to Keysight for repair |

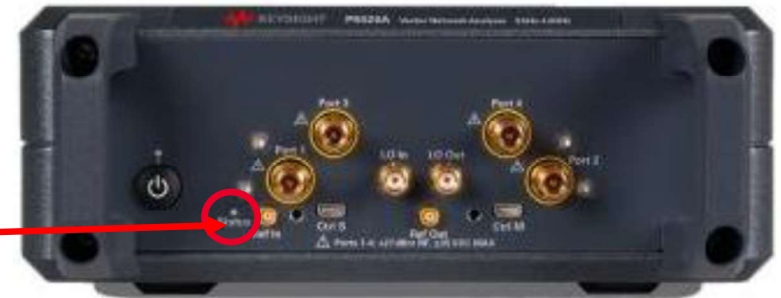
Instrument Status LED

| Symptom | Possible root cause | Solution |
|---|---|---|
| #3-3-2-1 Glowing amber | Power is ON, but firmware is not running. | <ol style="list-style-type: none"> ① Check if VNA firmware is working correctly. ② If not, go to Troubleshooting tips2-5 ③ Check if the cable between Streamline Series VNA and PC is connected correctly ④ If not, replace the cable ⑤ If the symptom still occurs, return it to Keysight for repair. |
| #3-3-2-2 Glowing red | PC battery is not maintained in a fully charged condition. Or A hardware error has occurred, or the VNA firmware is not installed or corrupted in the PC. | <ol style="list-style-type: none"> ① Make sure AC/DC adapter for the PC is connected. ② Check if VNA firmware is installed correctly. ③ If not, go to Troubleshooting tips 2-5 ④ If the symptom still occurs, check if Keysight IO Libraries Suites is installed correctly. ⑤ If not, go to Troubleshooting tips 2-4 ⑥ If the symptom still occurs, return it to Keysight for repair. |

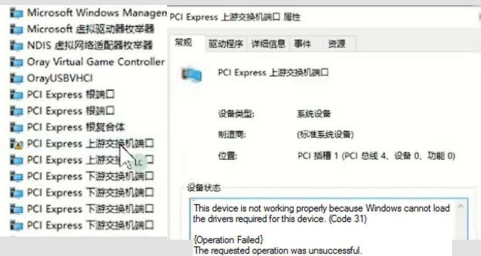
#3-6-8

For B models, Thunderbolt control center detects and recognizes the instrument correctly.

In Device Manager, the B model is not correctly recognized. Under “System Devices” > PCI Express Upstream/ Downstream Port shows Code31 error.

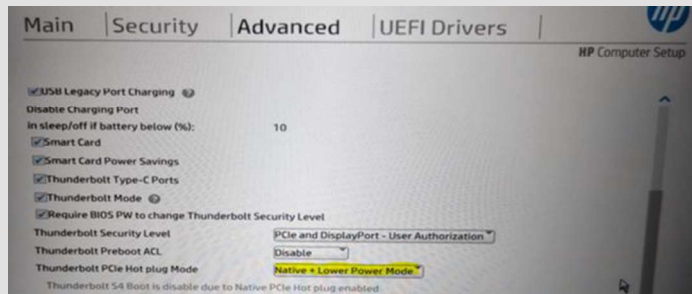
The root cause of this issue is due to declined Thunderbolt signal quality on PCIe Thunderbolt card for Desktop PC or Thunderbolt cable.

- ① Re-boot into BIOS (UEFI) settings.
- ② If Thunderbolt PCIe Hot plug mode is “Legacy Mode”, change it to “Native + Low Power Mode”.

Below is the HP BIOS settings sample.

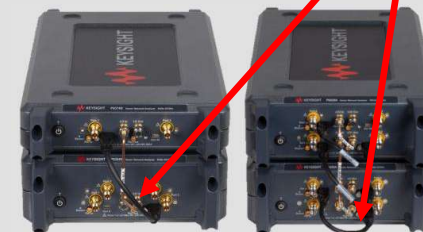
Interconnect cables for LO or control cable is not connected properly or broken.

- ① Check if the control cable (Black) is connected properly. If the connection is missing or loosened, connect it and tighten it with the nuts as shown in the image below.
- ② If the symptom still occurs, replace the control cable.
